Case Study

Wind Farm MVUG cable fault
Northeast Region, Brazil
June 2018

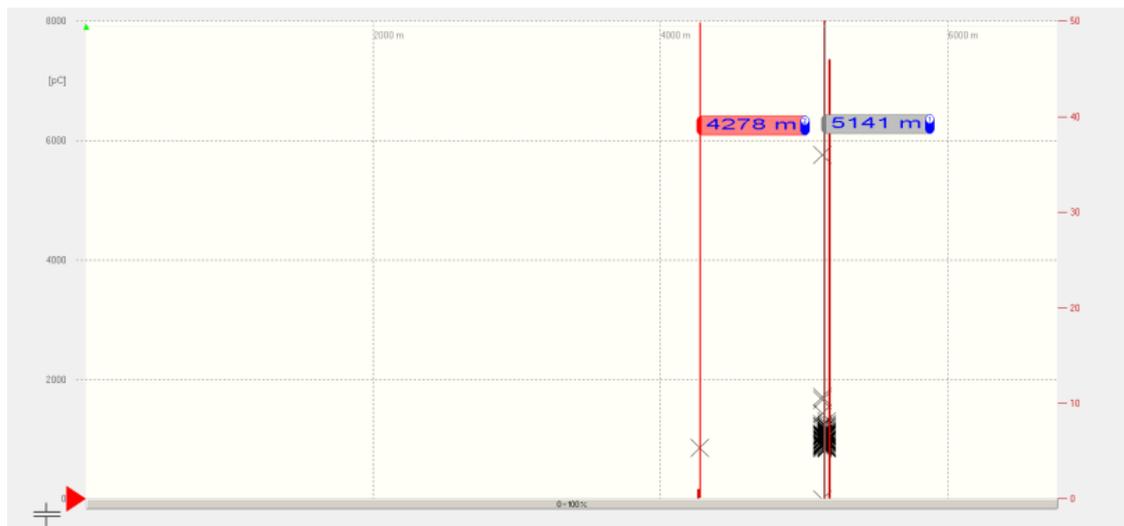
On 25th June 2018, during on site MVUG cables diagnostics, it was detected PD events at a splice (5141 m away from the Substation), with an inception voltage of 21 kV, $U_o = 20$ kV (see Figure 1).

Figure 1: LOC Diagram showing PD at 5141m

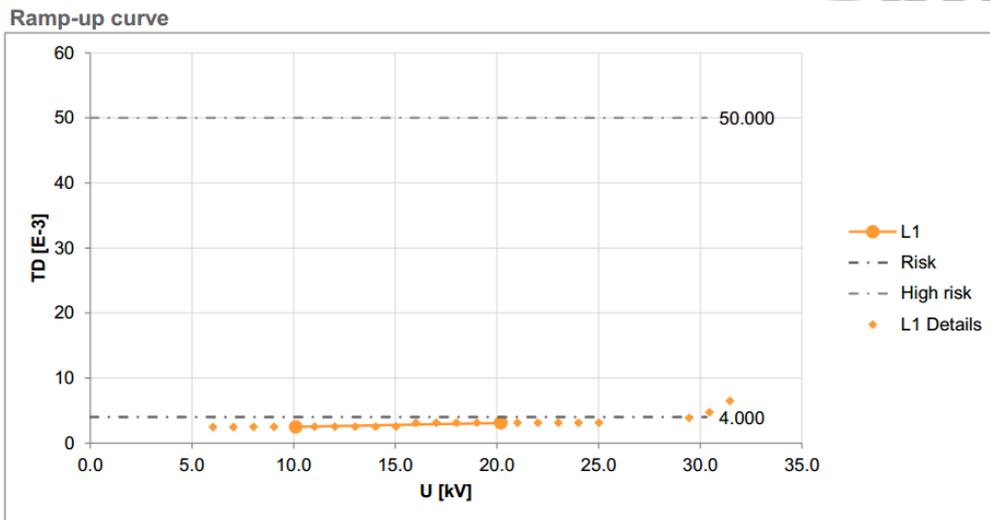
Furthermore, a Tangent Delta (TD) measurement was performed on this cable, in parallel with partial discharge test. During TD $1.5 \cdot U_o$ stage (30 kV), the cable has failed. The figure 2 shows the tan delta behaviour before the flashover. Before the fault, the tangent delta amplified drastically!

Figure 2: Tan delta ramp-up curve

After the fault, a VLF 0.1 Hz withstand test voltage of 23 kV was applied successfully across the insulation, to check if the cable could return to service and then a corrective maintenance could be scheduled at the damaged splice.

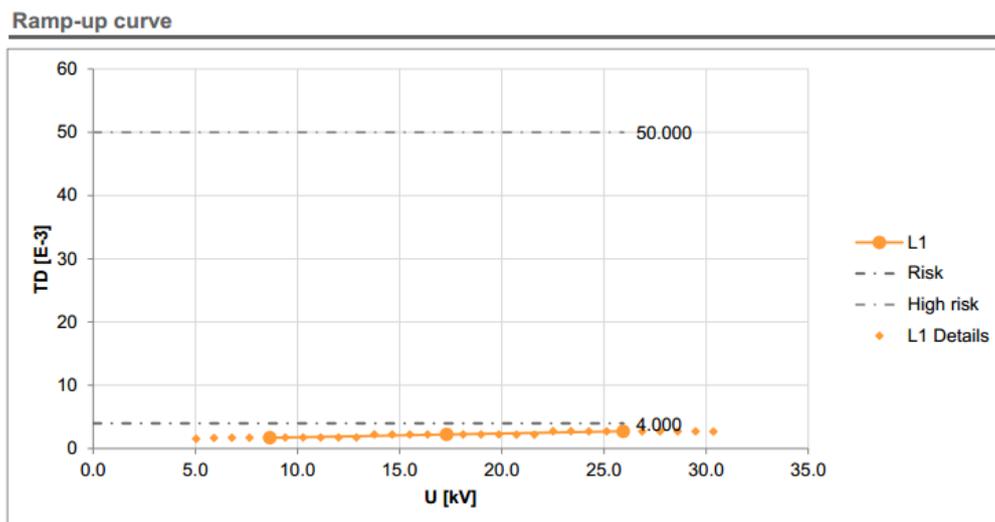
Figure 3: Ramp-up curve after the repair

One week after the tests, the splice was replaced and a new PD and tangent delta measurements were done. At this time, no PD was observed in the new splice, and all tangent delta parameters were at the NO ACTION REQUIRED category, according to the IEEE Guide For Field Testing Shielded Power Cable Systems Using Very Low Frequency (IEEE 400.2-2013). The cable was tested at $0.5 \cdot U_0$, $1.0 \cdot U_0$, $1.5 \cdot U_0$ and also 15 minutes of measurements at 33 kV testing.

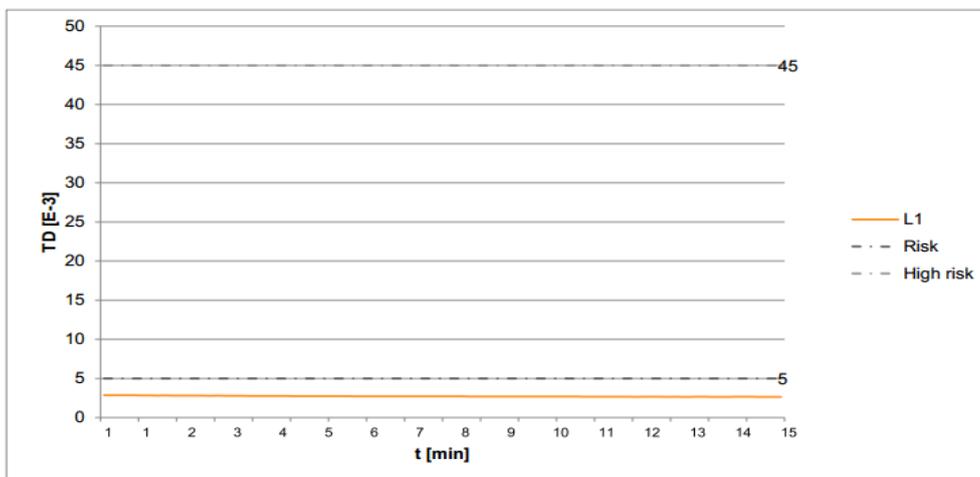
Figure 4: 33 kV MWT curve after repair
